# Coppicing Hardwoods for Renovation of Dairy Shed Effluent

## The Proposed System

## Experimental Work

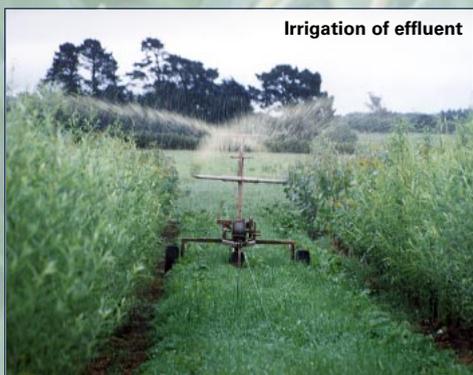
Irrigation of effluent

Trees offer a potential solution to nitrogen contamination of ground or surface water if drainage from effluent irrigated pasture is captured by a tile drainage system and re-used by irrigation onto poplars and willows planted at high densities. Alternatively the effluent can be directly irrigated onto the trees and their ability to utilise the water and nitrogen exploited to maintain low subsoil nitrogen concentrations.

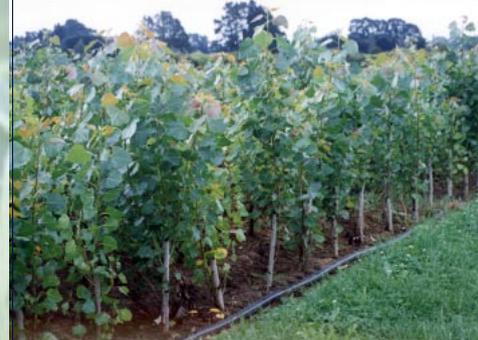
## Argyle poplars at the Arnold Farm

A 3-year demonstration trial incorporating ‘Tangoio’ willows, ‘Argyle’ poplars and a pasture control has been established on the Arnold dairy farm in southern Wairarapa. Effluent is directly irrigated onto the trees at either a high rate (5 mm every 10 days), or a low rate (2.5 mm every 10 days).
